North Kent Wind Community Liaison Committee Open House

CLC Meeting #3

May 16, 2018

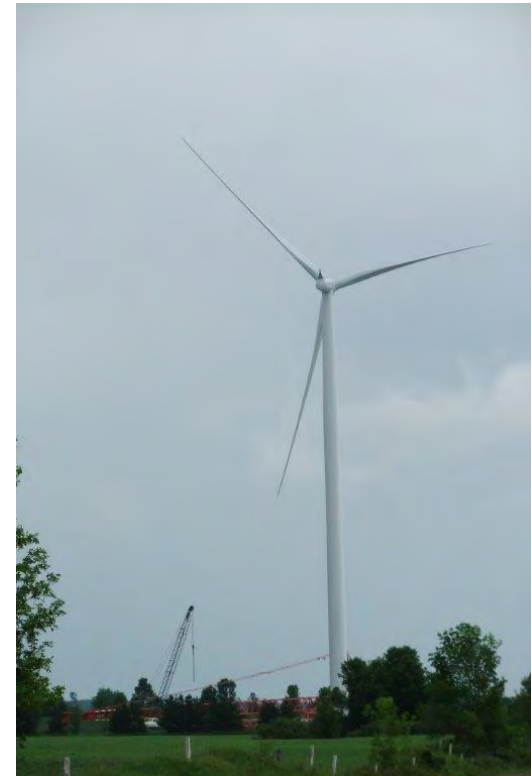
- Turbine Manufacturer: Siemens Energy
- Number of Turbines: 34
- Turbine model: Siemens SWT-3.2-113
- Rated wind speed: 12 to 13 m/s
- Hub height: 99.5 m
- Blade length: 55 m
- Turbine blades manufactured in Tillsonburg
- Turbine towers manufactured in Windsor

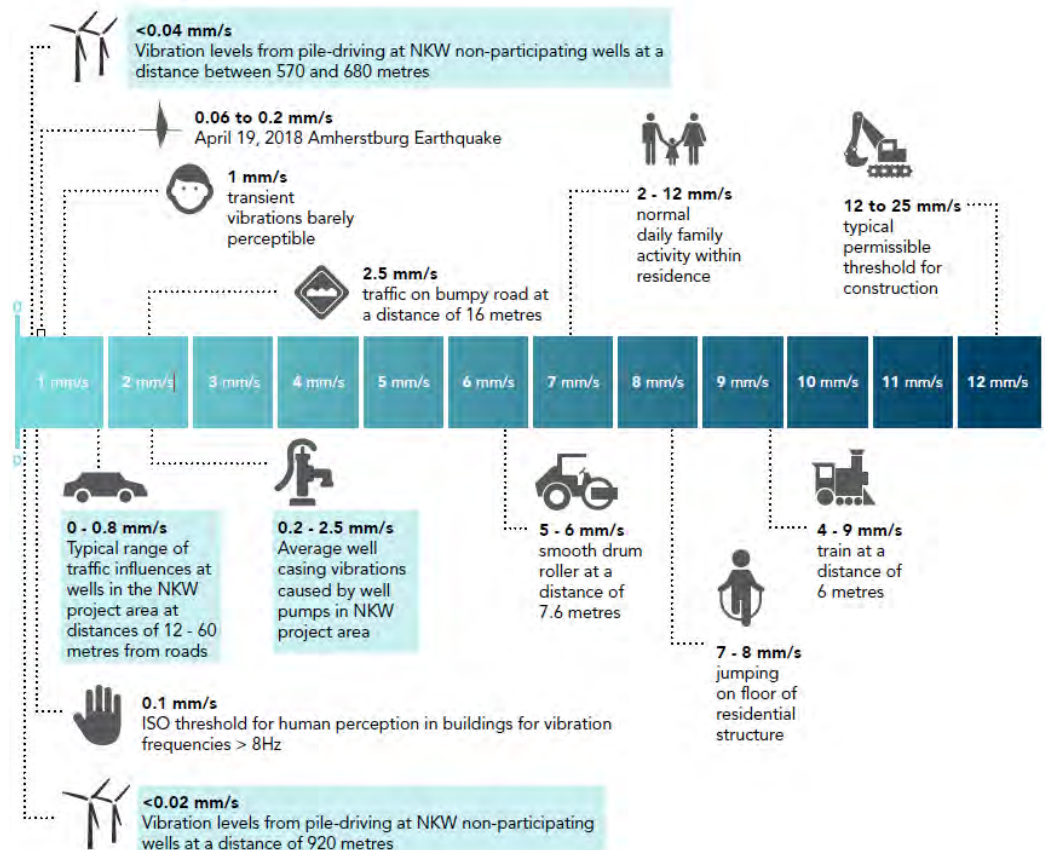
Construction Pile Driving Vibration Monitoring Results (Phase 2)

- Pile-driving occurred between June and November, 2017 at 500 metres or more away from water wells. Since construction, vibrations have been monitored in the rock and on steel well casings near operating turbines (Phase 3)
- The vibration monitoring program concluded that the vibrations at water wells were so minor that vibrations could not cause damage to well infrastructure or suspension of sediment

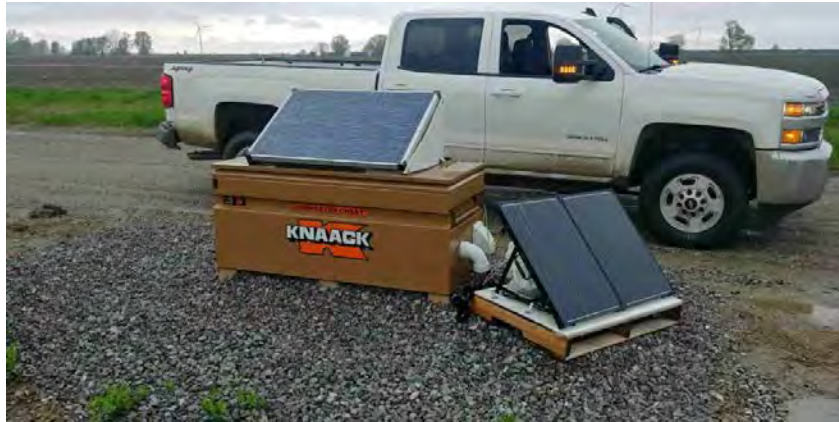
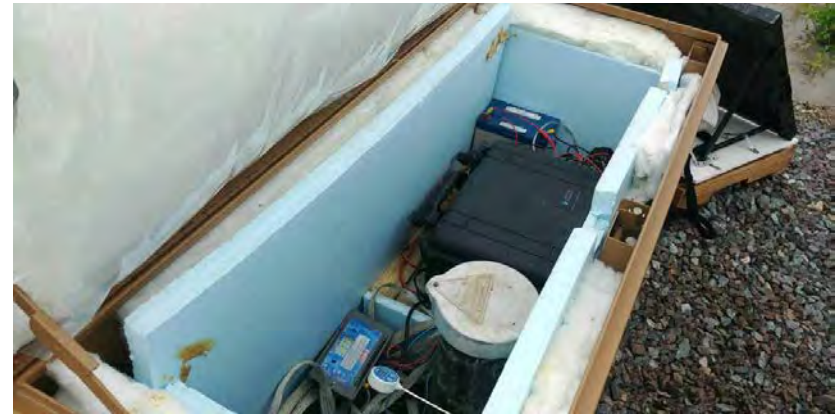
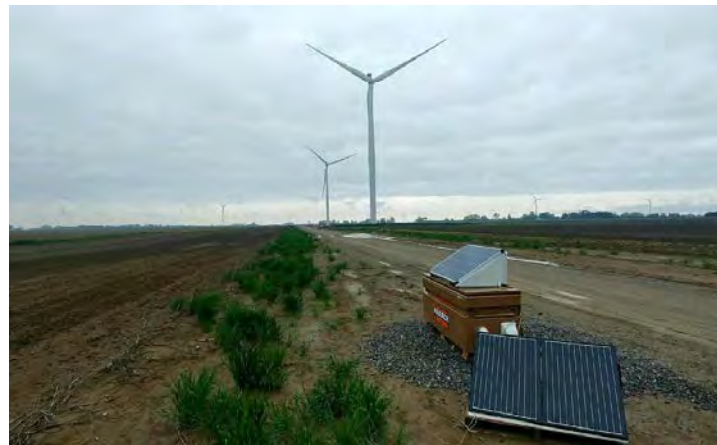
Operational Vibration Monitoring Program (Phase 3)

Long-term ground vibration monitoring is ongoing at four turbine sites. In-ground instruments at one test pile site have been supplemented at three other turbines with the following:

- Vibration monitoring equipment mounted to top of new steel water well casings, similar to most water wells in the area and well casing monitoring during construction
- Instruments cemented into bedrock below bottom of casings
- Vibration monitoring equipment has also been mounted on the foundations of four turbines
- One turbine also includes vibration monitoring sensors mounted inside the tower

These systems are regularly collecting large amounts of data. Over the next three years, this data will be examined periodically to evaluate the character of vibrations in comparison to turbine operations, meteorological conditions and any water well complaints.

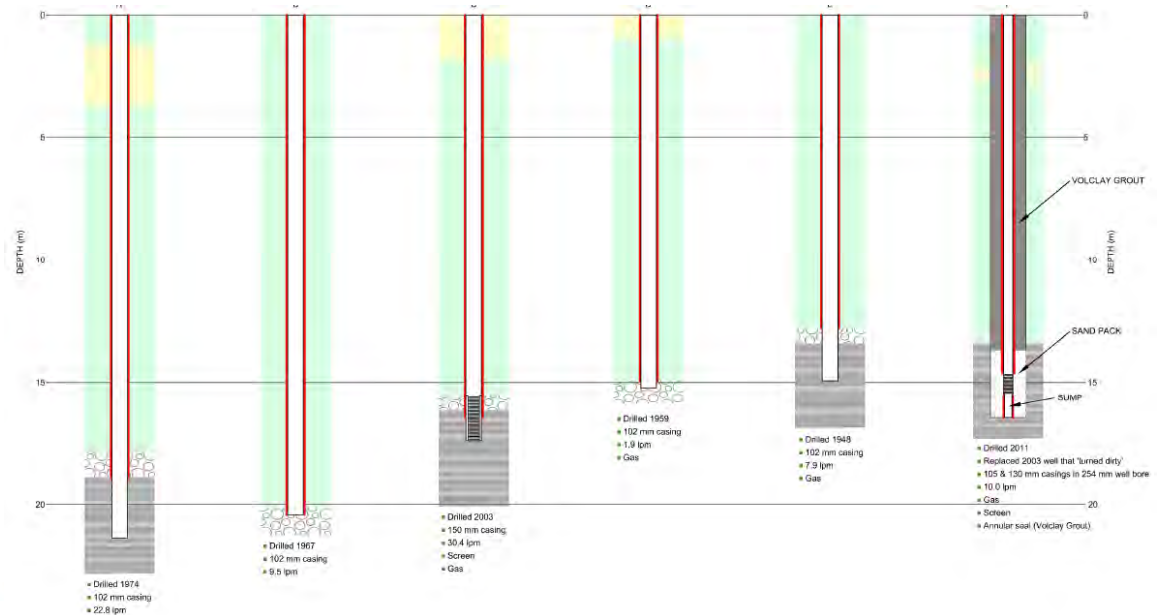
Wells in the Area

- Old wells often without screens
- Some new wells with screens & sumps
- Drilled in black Kettle Point Formation & glacial till
- Well “turned dirty” and abandoned in 2011
- Gas observed
